Malaysia Architectural  
Journal

## Do Renovation of Kominka Offer an Efficient Path to Town Revitalization and Energy Efficiency?

For this study, newly renovated *kominka* now used as multipurpose library has been investigated during the wintertime with and without use of air conditioning systems (AC). The surveyed building is in Omori area in Oda city, Shimane prefecture, once home to a silver mine whose production reached one-third of the world's silver nearly four centuries ago (between 1526–1923) [11]. During that time, the population of the town was approximately 200,000, which declined sharply after the mine was closed in 1923. Following the closure of the mine, the town became deserted as residents moved away and abandoned wooden houses disintegrated, eventually reclaimed by dense forest labelling into a ghost town [12]. With the combined efforts of local government, business, and the community, Omori ginzan area was established as UNESCO world heritage site in 2007, transforming from a ghost town to a vibrant community. To maintain the historic landscape of the town, these buildings are renovated with no external wall insulation that can lead to an increase in energy cos

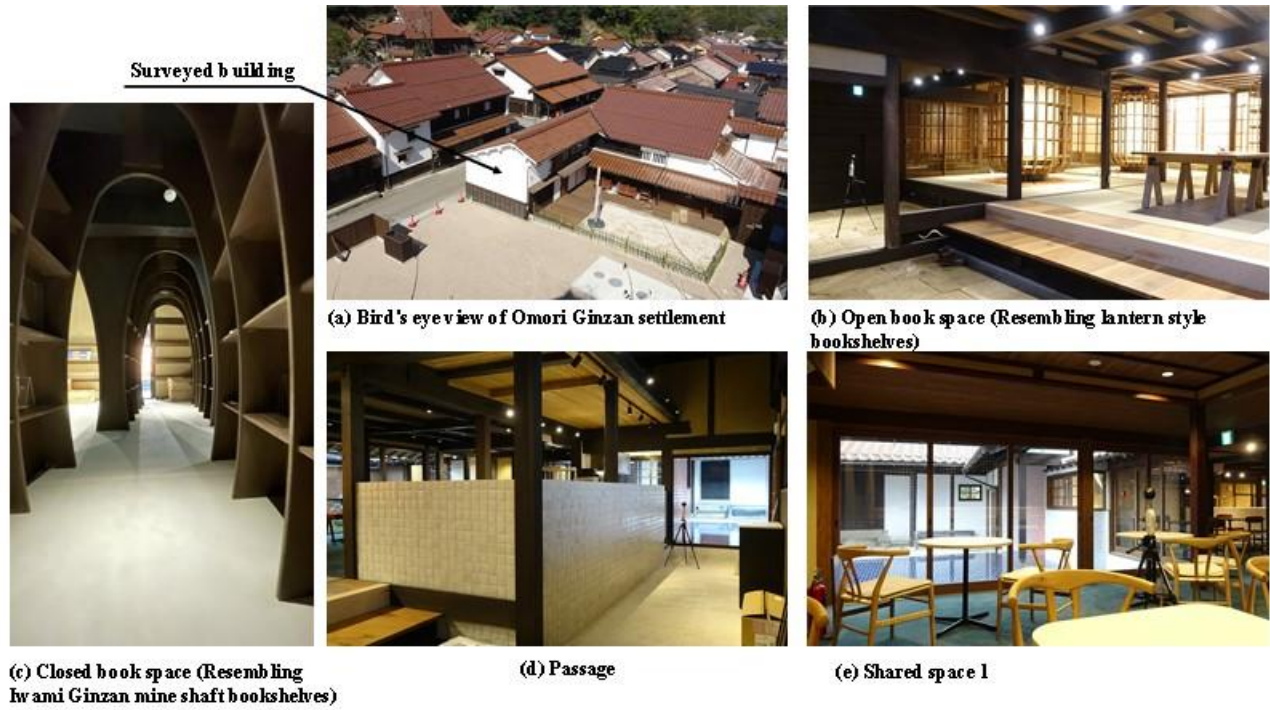
**Fig. 2.** Interior view of first floor showing (a) Omori Ginzan settlement (b) Open book space (c) Closed book space (d) Passage (e) Shared space 1

**Fig. 2-3** presents the exterior and interior views, while the architectural planning is illustrated in **Fig. 4**. On the first floor there are two library spaces, one with lantern style bookshelves and another with Iwami Ginzan mine shaft bookshelves (see **Fig. 2 (b-c)**). For this measurement, these two library spaces are named as open book space (resembling lantern style bookshelves) and closed book space (resembling mine shaft bookshelves) (see **Fig. 4 (a)**). The red dot seen in the architectural planning represents the thermal measurement points on the first and the second floor (see **Fig. 4**).

**Fig. 2-3** shows the interior view of surveyed building with the thermohygrometers placed 1,100 mm height from the base in the center of each room. The thermohygrometers used for indoor measurement was an A&D AD-5695DL with the measurement accuracy of  $\pm 0.6$  °C and range of 0-50 °C. Similarly, the thermohygrometers used for outdoor and foundation was a T&D TR72A with the accuracy of  $\pm 0.5$  °C and range of 0-55 °C. Additionally, an Eko MS-40 pyranometer with a sensitivity of approximately  $10 \mu\text{V}/\text{W}/\text{m}^2$  was set on the south side in the patio to measure the solar irradiance of the day during the measurement time.

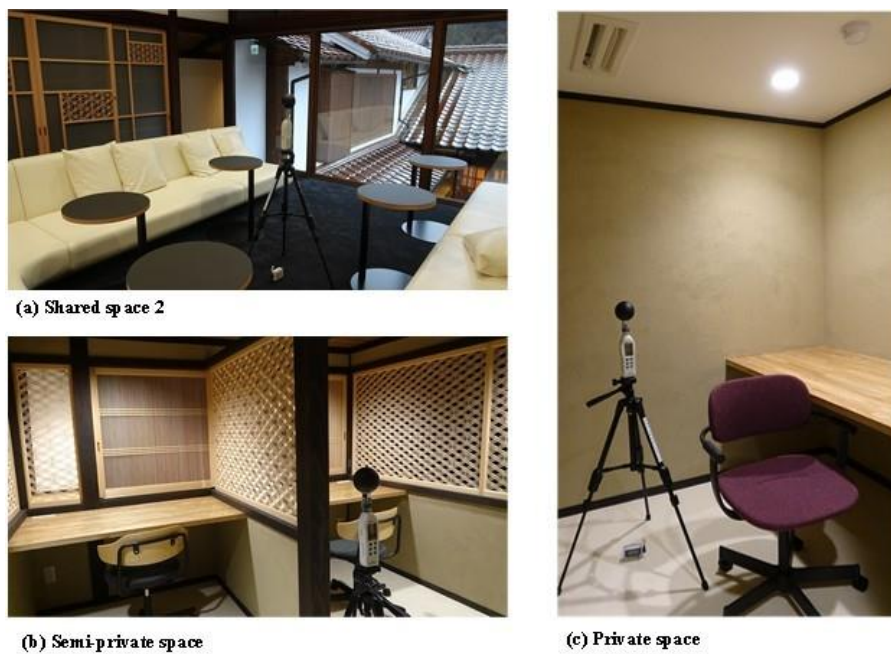
**Fig. 3.** Interior view of second floor showing (a) Shared space 2 (b) Semi-private space (c) Private space

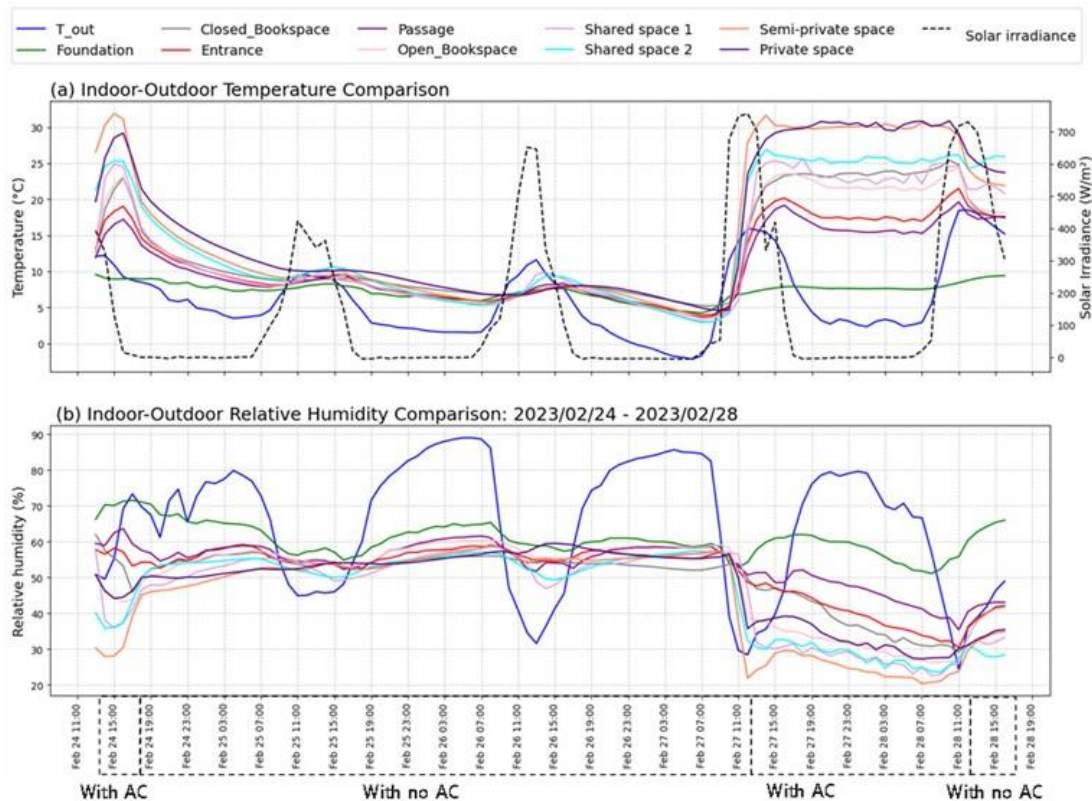
**Fig. 5 (a)** compare the indoor-outdoor temperature and solar irradiance distribution for the whole measurement time. On the first day, when AC was turned on for 4 h, the indoor temperature of semiprivate space reached 31°C followed by private space 29 °C within 2 hours of heating. While the shared space on the second and first floor elevated to 25 °C and open and closed book space rose to 21 °C. Similarly, the entrance and passage remained between 16-18 °C during the time, the outside temperature was found to be approx. 10 °C. Next AC was turned off for 66 h, the indoor temperature of all measured places ranges between 5-10 °C while the outdoor temperature was fluctuating throughout the day and nighttime (minimum -2 °C and maximum 14 °C). Afterward, AC was turned on for 24 h, the indoor temperature at semi-private and private space tended to stabilize between 28-30 °C while shared spaces in the second and first floor remained between 25-26 °C and open and closed book space between 21-22 °C throughout the AC time. The indoor temperature at entrance and passage ranges between 15-18 °C whereas outdoor remained between 11-15 °C during daytime and below 5 °C during nighttime. In contrast, temperature at foundation remained steady between 5-9 °C during the measurement period. Similarly, increase in solar irradiance during daytime shows little effect in the indoor temperature of the measured places.

**Fig. 5.** Winter measurement for four days (a) Indoor-outdoor temperature comparison (b) Indoor-outdoor relative humidity comparison

**Fig. 5 (b)** compare the indoor-outdoor relative humidity (RH) for the whole measurement time. During the daytime, the outside relative humidity ranges between 40-50% while at nighttime increase to 70-80%. Without using AC, relative humidity for all measured indoor spaces remained between 50-60% during day and night-time. After using AC, the relative humidity reduced to 35-45% at all measured indoor spaces. In contrast, only slight changes (55-60%) were recorded in the relative humidity in foundation during both day and night.

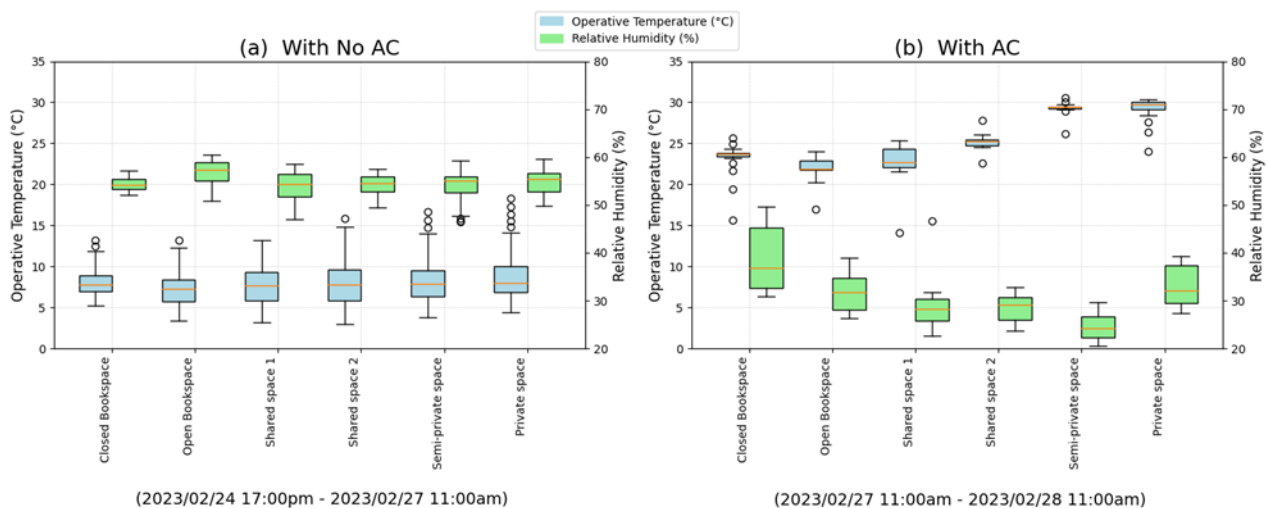
**Fig. 6** evaluate the comfort condition of the measured rooms with and without AC. **Fig. 6 (a)** compare the operative temperature and RH trends and variability in the indoor measured spaces without using AC. During the time, all measured rooms exhibit smaller interquartile range of operative temperature 6-9 °C and RH 50-60%, indicating lower variability during the day and night. Due to the use of AC on the first day (13:00–17:00 pm), shared space 2, semiprivate and private space’s average operative temperature and RH remained relatively high 15-17 °C and 45-50% respectively during the night. Therefore, there are outliers on the higher end in the operative temperature of these spaces.

**Fig. 6 (b)** compare the changes in the operative temperature and RH in the indoor measured spaces after using AC. During the time, interquartile range of private and semiprivate space’s operative temperature was notably small, indicating very narrow range of temperature variation (29-31 °C) within the period. In the case of other rooms, shared space 1 and 2, open and closed book space’s operative temperature tended to stabilize between 22-25 °C, suggesting that all the room temperature remains relatively constant and stable when AC was used. While RH decreased sharply, with the minimum (below 30%) observed in semiprivate space, shared space 1 and 2. In contrast, closed book space exhibited wider interquartile range, with the RH ranging from 30-45% during the day and night. During the period, RH of closed book space and private space was found between 26-36% and 30-40% respectively.

**Fig. 6.** Comparison of operative temperature and relative humidity within the measured rooms with and without AC

between 11-15 °C during daytime and below 5 °C during nighttime. This shows all rooms except entrance and passage was found to be more than 20 °C warmer than outside temperature during nighttime. Similarly, the operative temperature of private and semiprivate space was found to be 29-31 °C, while other rooms, shared space 1 and 2, open and closed book space was found between 22-25 °C with minimum RH below 30-45%. Based on the thermal comfort set by ASHRAE standard 55 [17], 96.5% of the complaints occurred at temperatures less than 21 °C and RH 30% or greater than 24 °C and RH above 60%. This indicate semi-private and private spaces is likely to be too warm due to excessive heated, which lead to discomfort for occupants. Shared spaces in the second and first floor located in south is likely to be slightly warm, while open and closed book space remained between 21-22 °C within the ASHRAE standard indicating comfortable condition.

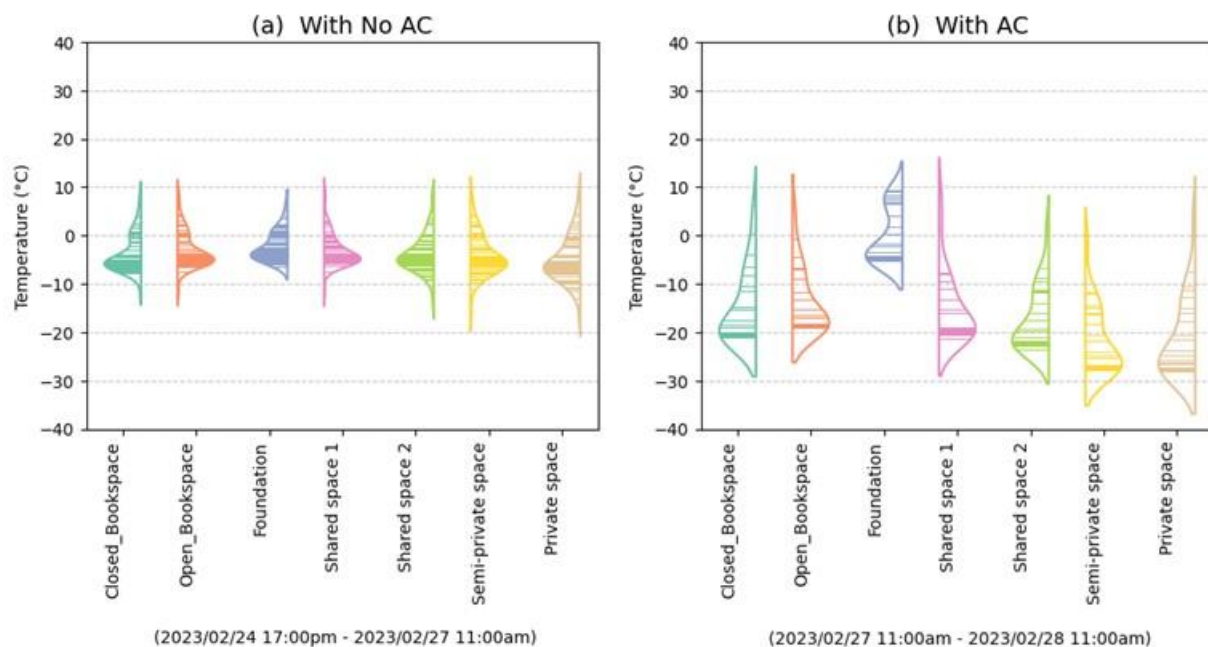
**Fig. 7** compare the thermal performance of the surveyed building based on the indoor-outdoor temperature differences with and without AC. **Fig. 7 (a)** shows the differences between indoor-outdoor measured places without using AC during 66 h of measurement time. The indoor temperature of all measured places was found to be 5-7 °C warmer than outside temperature during the nighttime, while minimum temperature difference (0.5-1 °C) was found during the daytime. On the first day when AC was turned off after 4 h, shared space 2, semiprivate and private space remained warmer (8.5-11 °C) than the outside temperature at night without AC while the other rooms exhibited similar tendency, being 6 °C warmer.

**Fig. 7. (b)** shows the temperature differences between indoor-outdoor when AC was turned on for 24 h. During the nighttime, closed and open book space and shared spaces 1 and 2 were found to be 18-21°C warmer, while semi-private and private spaces were found to be 27-28 °C warmer than outside temperature. Whereas in the daytime, maximum temperature differences were found to be approx. 10 °C between measured places.

**Fig. 7.** Temperature differences within the spaces with and without use of AC
